Ferrographic Study of Wear Particles in Used Oil of a Machinery System in Power Generating Plant

Abstract: This study analyses wear particles in fresh and used oil lubricant of the samples collected from the power generating plant of Faculty of Engineering, Ekiti State University, Ado Ekiti Nigeria. Viscosity measurement, elemental/mineral analysis and ferrographic analysis were done using a Viscometer, Atomic Absorption Spectrophotometer and a ferrogram maker. The elemental analysis shows the presence of elements such as iron, copper, aluminum, silicon, chromium, tin and lead. However, fresh oil used contained elements such as iron, copper, silicon, chromium and lead, which suggests that not all wear particles found in the used oil were from the observed machinery. The result of the elemental/mineral analysis indicates that the quantity of elements in the used oil increased as the working hour increased. The result further shows that as the running hour of the engine oil increased, there was an increase in the deposition of wear of the internal parts of the plant. However, iron was observed to have the highest deposition rate followed by copper with tin having the least quantity

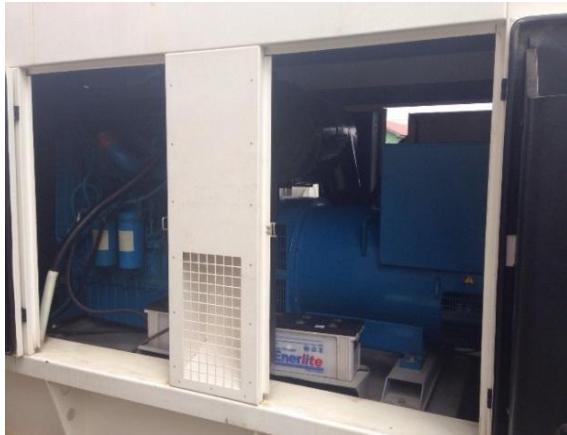
Fig. 3.1: Faculty of Engineering power generating plant

The features of the Faculty of Engineering, 500 KVA power generating plant are presented in Table 3.1.

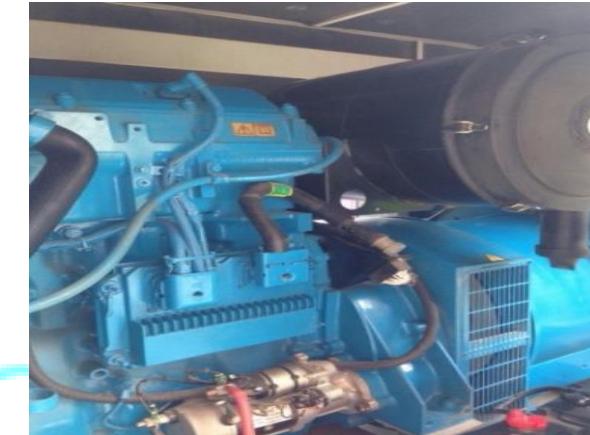
Fig. 3.2: Engine compartment of the power generating plant
